ORIGINALLY ISSUED  
June 1945 as  
Confidential Bulletin L5E22

FLIGHT INVESTIGATION AT HIGH SPEEDS OF FLOW CONDITIONS

OVER AN AIRPLANE WING AS INDICATED BY SURFACE TUFTS

By Clotaire Wood and John A. Zalovecik

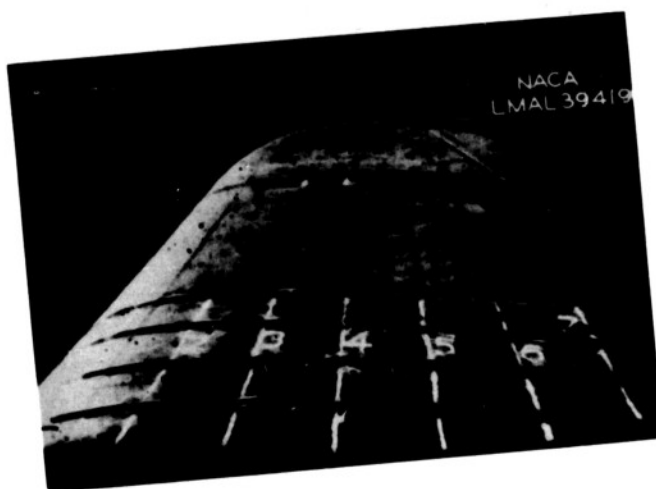
10  
Fig. 4

Figure 4.- Photograph showing tuft behavior at an airplane lift coefficient of 0.49 and at an airplane Mach number of 0.71.

An enlargement of one frame of the motion-picture film taken during flight is shown as figure 4. The quality of the photographs was, in general, too poor to permit satisfactory reproduction in this form; in figures 5 to 8, therefore, sketches based on the original photographs are used to illustrate, for a few typical flight conditions, the flow conditions indicated by the tufts. The flow conditions for various airplane lift coefficients at constant airplane Mach numbers of 0.69 and 0.71 are shown in figures 5 and 6, respectively; the flow conditions for various airplane Mach numbers at constant airplane lift coefficients of 0.13 and 0.43 are shown in figures 7 and 8, respectively. Inasmuch as the field of the camera covered only the forward 70 to 80 percent chord, the flow conditions downstream of this region are not known.

The flow conditions indicated by the tufts at various lift coefficients and Mach numbers are summarized in figure 9. The interpretation of the behavior of the tufts is as follows: Tufts lying straight back and motionless indicate smooth flow, tufts oscillating laterally indicate unsteady flow, and tufts "flopping" around leisurely or lying curved on the surface indicate flow separation. (Compare figs. 4 and 6(d).)
